# Mobile Intel<sup>®</sup> Pentium<sup>®</sup> II Processor Specification Update

Release Date: September 2006

Order Number: 243887-055

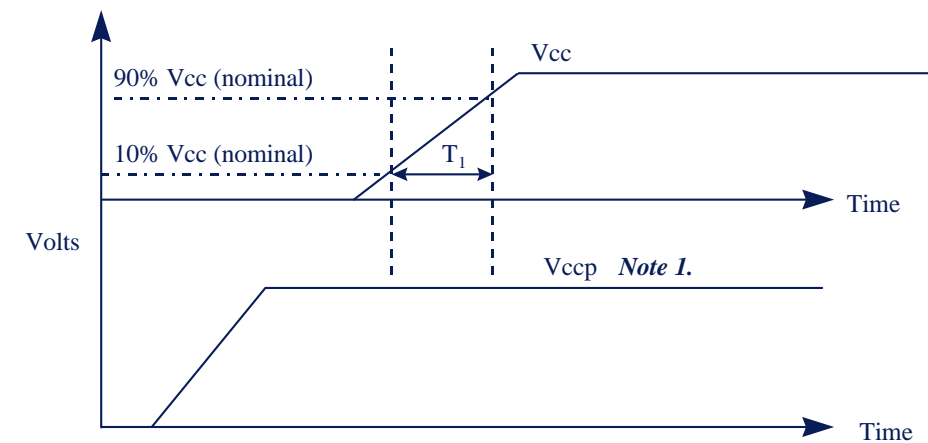
**Figure 1.  $V_{CC}/V_{CCP}$  Timing Requirements (Mobile)**

**Problem:** The processor uses the PWRGOOD signal to ensure that no voltage sequencing issues arise; no pin assertions should cause the processor to change its behavior until this signal is asserted, when all power supplies and clocks to the processor are valid and stable. However, if  $V_{CC}$  ramps up before  $V_{CCP}$ , it will cause the processor to enter an invalid state.

**Implication:** If this erratum occurs, the system may boot normally however, the L2 cache may not be initialized.

**Workaround:** For Mobile Pentium II processors, ensure that  $V_{CC}$  ramps after or with the L2 cache IO voltage ( $V_{CCP}$ ). If  $V_{CCP}$  ramps after the  $V_{CC}$ , a delay circuit can be placed on the core  $V_{CC}$  to ensure that  $V_{CC}$  ramps at the same time or after  $V_{CCP}$  as shown below in Figure 1.

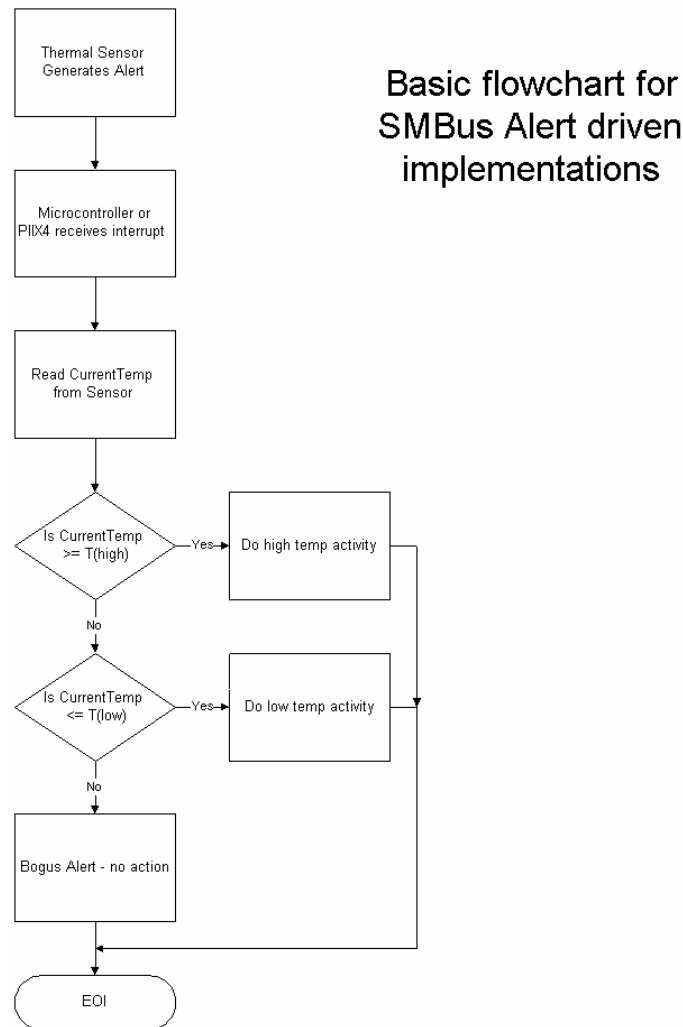
Figure 2. Workaround Flowchart: SMBALERT#-Driven System

Under the conditions described below, the thermal sensor incorrectly generates the SMBALERT# interrupt. All of the following conditions must be met to trigger a false interrupt:

1. Before servicing an interrupt from the thermal sensor, read and compare the processor thermal reading with the threshold limits ( $T_{HIGH}$  or  $T_{LOW}$ ). Figures 2 and 3 provide basic flowcharts for the implementation of this workaround in an interrupt driven system.
2. If the firmware implemented polls the Status Register only, then before taking any action, re-read the temperature register and do a comparison with the alarm threshold limits ( $T_{HIGH}$  or  $T_{LOW}$ ) to determine if the value is actually still within the temperature window.
